Corrosion failure analysis of hearing aid battery-spring contacts

Gudla, Visweswara Chakravarthy; Ambat, Rajan

Published in:
Engineering Failure Analysis

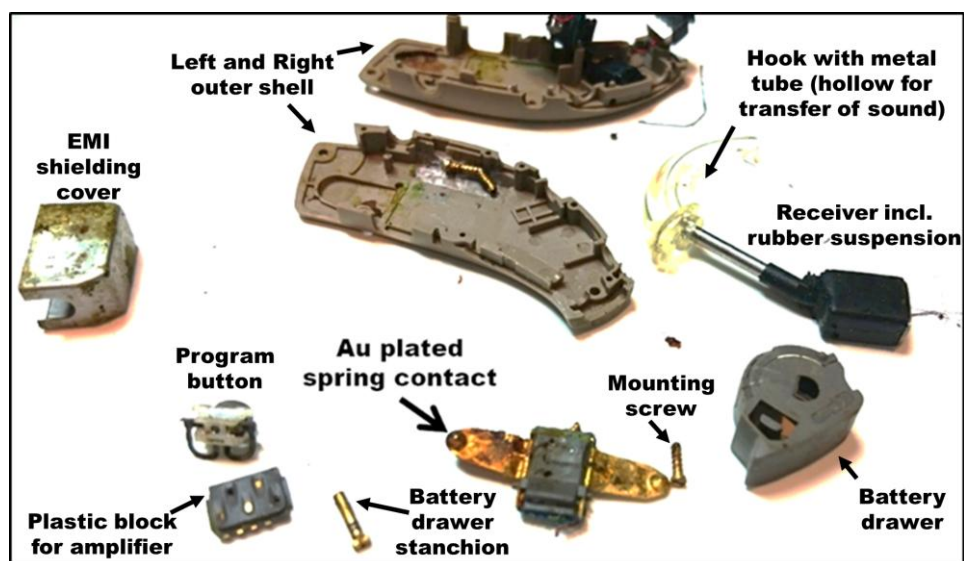
Behind the ear hearing aid devices installed with Au plated battery spring contacts were obtained from the field after being in service for different periods. The metal spring contacts were then carefully separated from the rest of the device and were prepared for analysis of the contact surface (see Figure 2). The springs are numbered sequentially as *Contact-1*, *Contact-2*, *Contact-3*, *Contact-4*, and *Contact-5*. The separated springs were then mounted for electron microscopy observations onto an Aluminium stub, and painted with conductive Ag paint around the edges to prevent charging. Scanning electron microscopy was performed on the contact surfaces using a SEM Quanta 200 ESEM with Oxford X-max EDS capability. In addition, selected areas were subjected to focused ion beam milling for in-situ observation of the cross sections using a Helios Nanolab dual beam FEG SEM.

Figure 2: Photograph showing a representative Au plated spring contact separated from the rest of the hearing aid device.
